COMMON CAUSES OF LEAKS

When your Gleco Trap is properly installed, it shouldn't leak. But if it does, here are a couple of common problems and solutions. If your problem is not solved by these notes, contact us and we'll talk about your specific situation.

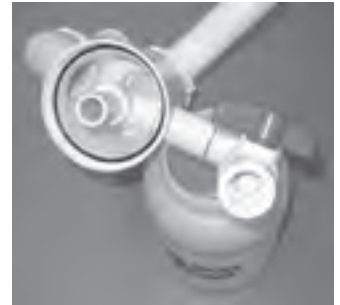
Properly seated O-Ring

1. The O-Ring is out of place or crimped.
 - Make sure it's seated in the channel provided.
 - If you are installing a brand-new O-Ring, give it a quick tug to stretch it slightly and dab a little petroleum jelly on it (or into the channel) before installing - it will fit into the channel a lot easier.

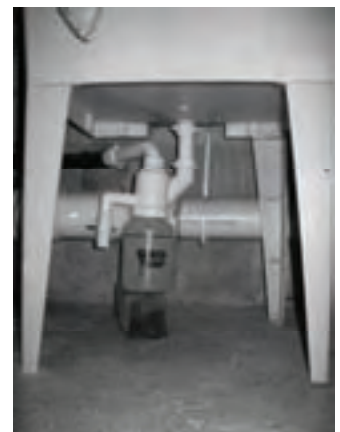
Misaligned installation

6. Check the valve - you might not have gotten it completely shut.
7. Install The Gleco Trap so it hangs plumb. Don't cut corners on checking this part when installing The Gleco Trap. If it doesn't hang straight down, the weight of the bottle when it's hanging at a slight angle can prevent a good seal with the O-Ring as well as creating added pressure on the threads of the bottle. See the picture marked "misaligned installation" for an example. Notice how the slight angle led the customer to believe that support (the wooden block under the Gleco Trap) was needed? This installation also leads into our next problem.

8. If you have a utility sink, make sure that it's secured to the wall or floor so it doesn't move (which caused The Gleco Trap to hang at a slight angle in the example above). Even if you've taken the time to make sure it hangs plumb on installation, a bump of the sink when it's unsecured could pop the seals on your connections to The Gleco Trap and create a leak.

9. Bad connections to the sink drain or the wall waste line can cause leaks. In the example above, the waste line shows a light raise after The Gleco Trap, where it should be parallel to the floor.
